THESIS

PLASTIC INSTABILITY OF ALUMINIDE AND PLATINUM
MODIFIED DIFFUSION COATINGS DURING
1100°C CYCLIC TESTING

Thomas F. Manley, II

December 1985

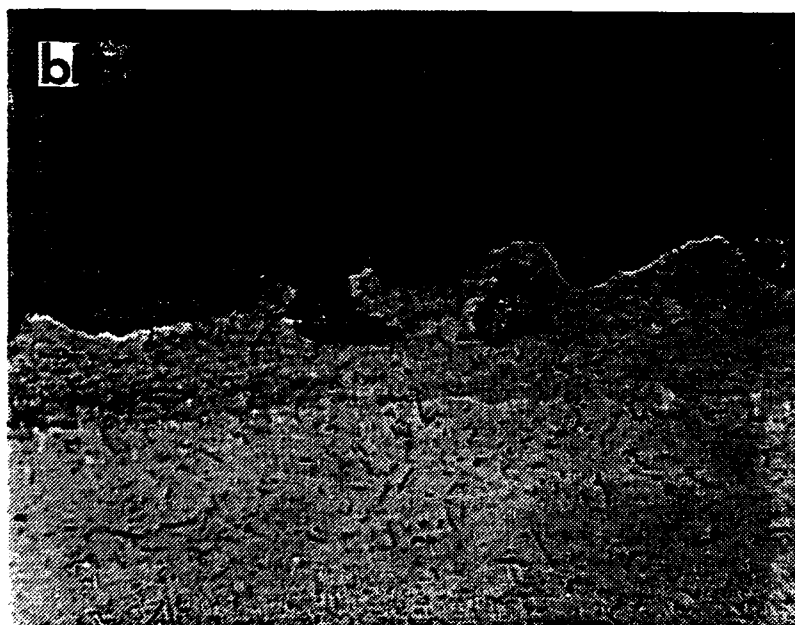
Figure 17. Thickness Rumpling Effect for Similarly Processed Platinum Aluminide Coatings (250x): a) 4IIB, Thick Coating, Cycled 150 hrs; b) 4IIB, Thin Coating, Cycled 150 hrs
